## Maryland Inventory of Historic Properties Form

Inventory No. M:26/13/16

historic Fred and Mary Nellinger House

street and number 419 Reading Avenue \_\_\_\_\_ not for publication

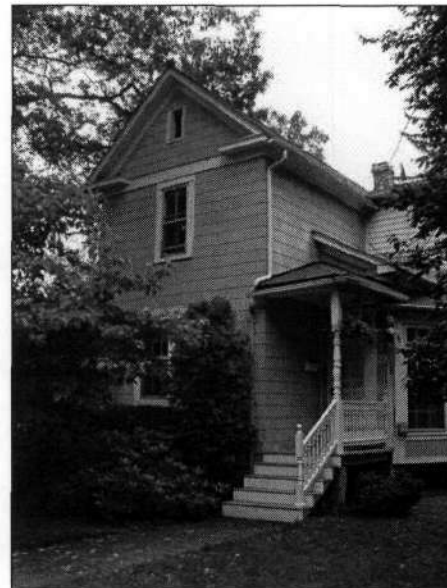
Photo 1: North elevation

The north façade (Photo 1) with front-gabled roof and cornice returns has two six-over-six windows with a mullion on the first floor not original to the first build and an original two-over-two window on the second floor directly above. A small rectangular gable window lights the attic. The north-facing front entrance with original transom and door is extended from the house under a shed roof. Originally, this shed roof probably extended south covering the first story of the southwest room, which was removed for the addition of a second story bay window. A paneled half-light exterior door is wood and looks to be original to the first build. The eight-light storm door is also wood.

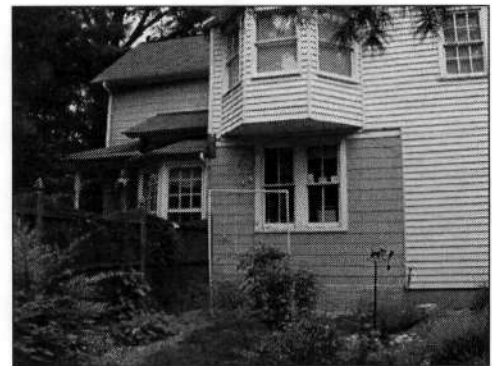
Photo 2: West elevation

The west elevation (Photo 2) consists of first build and c. 1980 additions demarcated by the asbestos shingles on the first build (blue) and vinyl siding (white) on the addition. The first story bay window west of the front entrance is not original; however, the two-over-two paired windows on the first story are original to the first build. The second story bay window with one-over-one windows is also part of the ca. 1980 addition enlarging the master bedroom. A six-over-six window is located on the second story addition just below the rake.

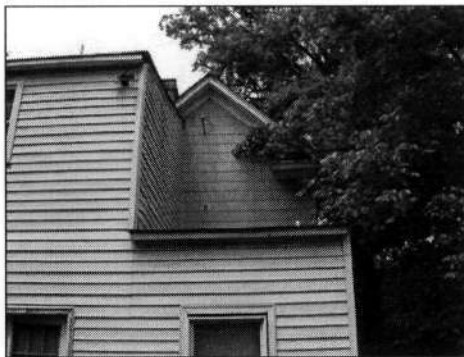
Photo 3: South elevation showing addition and gable end of first build

The addition extends to the south and is covered by a shed roof (Photo 3). The addition roofline is two stories on the western half and drops to one story before at the southeast corner of the first build. Steel French doors give access from the south addition into the backyard via makeshift CMU steps. There is one four-over-one window on the second story and a one-over-one window east of the back door.

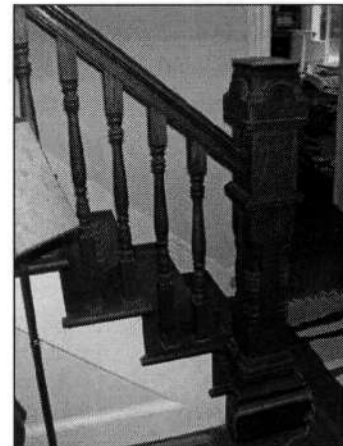
**Photo 5:** Newel post on first floor

Interior features of notable historic significance include the original staircase, featuring a decorative newel post and spindle balusters (Photo 5). The original yellow pine floor is still extant throughout the house, although it has been covered in the kitchen beneath slate tile. Bull's-eye moldings surround the interior doorways and windows within the original structure on both the first and second floors.

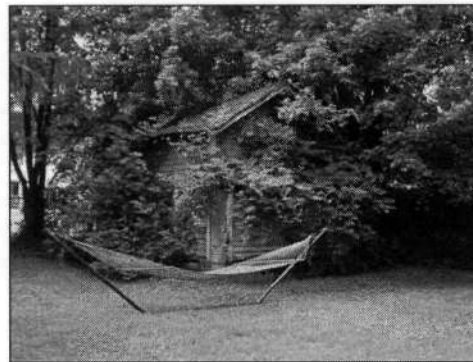
**Photo 7:** Accessory building two north and east elevations

The second accessory building in the southwest corner of the lot is supported with a CMU foundation and composed of frame construction with horizontal wood siding (Photo 7). This shed

also has a composite asphalt roof with exposed eaves. The shed was likely built prior to 1960 as indicated by the 1960 Sanborn map.<sup>3</sup> The foundation has shifted and foliage has taken over the exterior of the shed. There is also a hole in the roof, and overall, the shed is very dilapidated.
